Sediment Impairment Evaluation

Uwharrie Upper & Lower Lakes (<u>+</u> 15.75 acre site) James Landing Subdivision Jamestown, North Carolina 27282

James Landing Homeowners Association

June, 2013

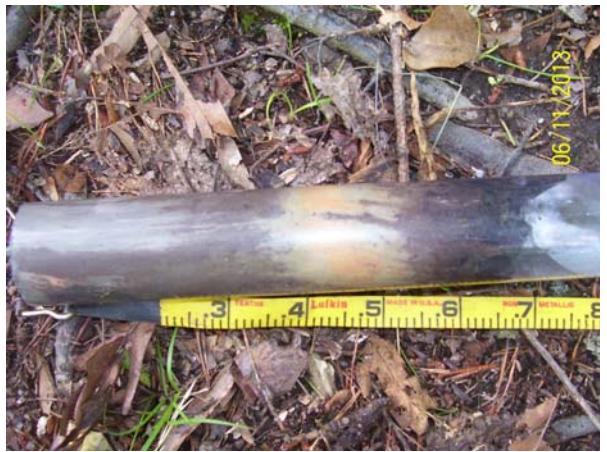
Photo 1: Sample #1, West lobe of large lake

Sediment stratification sample #1 revealed approximately 0.18 feet of sediment recently deposited since the accumulation of a layer of brightly colored clay soil (see Exhibit 6, Photo #1). This brightly colored clay layer may correspond with a period of development northwest of the upper lake that delivered disturbed soils to the lake through atypical runoff events or may be the result of increased oxygenation of the lake substrate from a previous summer. Sediment stratification sample #2 revealed approximately 0.14 feet of sediment recently deposited above an older silty clay layer (see Exhibit 6, Photo #2). Sediment stratification sample #2 revealed approximately 0.25 feet of sediment recently deposited above an older silty clay layer (see Exhibit 6, Photo #3). Sediment stratification sample #4 was inconclusive with respect to stratigraphy, as coarse-grained substrate was encountered uniformly to a depth of approximately 1.1 feet (see Exhibit 6, Photo #4). The elevated water levels on the date of sampling made it difficult to discern where the boundary of the lake would be found under normal conditions and as such, it is unclear whether the sample was gathered in an optimal location. Sediment stratification sample #5 was inconclusive with respect to stratigraphy, as coarse-grained substrate was

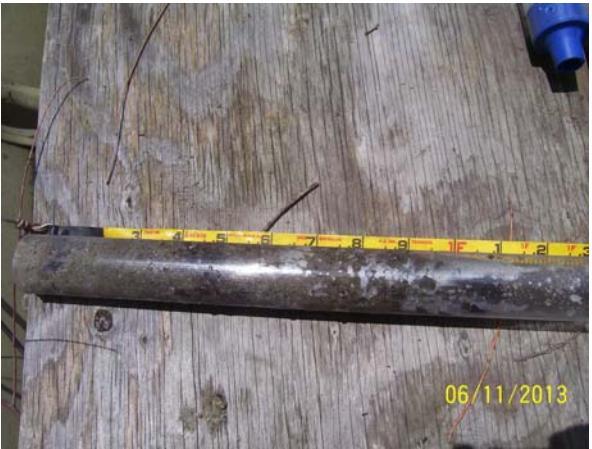
Photo 4: Sample #4, North lobe of large lake

Areas near sediment sample point #4 and sediment sample point #6 may require close examination in future analysis. Field observation revealed emergent depositional sediment features near these points that indicate an abundance of sediment being introduced to the lake from the corresponding streams. Findings indicating that seasonal sediment accumulation was highest at sediment sample point #6 are consistent with field observations of nearby emergent sediment features.

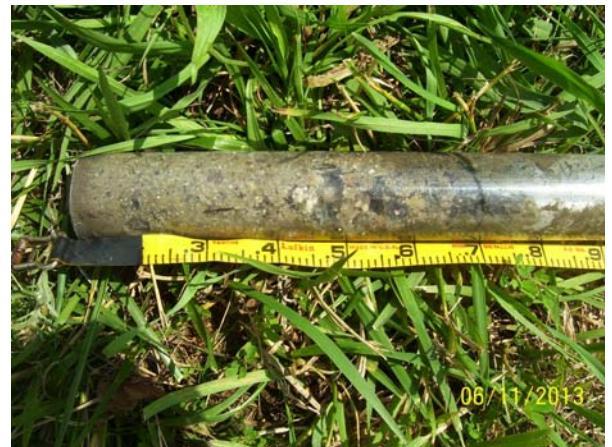
Photo 6: Sample #5, North lobe of small lake

encountered uniformly to a depth of approximately 1 foot (see Exhibit 6, Photo #6). Due to the proximity of this sample location to the dam outflow into the lower lake, as well as field observation indicating that water flow around this location can reach substantial velocity, it is likely that all organic material and sediment that is not of significantly coarse nature is carried out into deeper portions of the lake downgradient. Sediment stratification sample #6 revealed approximately 0.44 feet of sediment recently deposited above an older silty clay layer (see Exhibit 6, Photo #7).
